Nuclear Instruments and Methods in Physics Research A 515 (2003) 166–179

Aging studies for the ATLAS Transition Radiation Tracker (TRT)

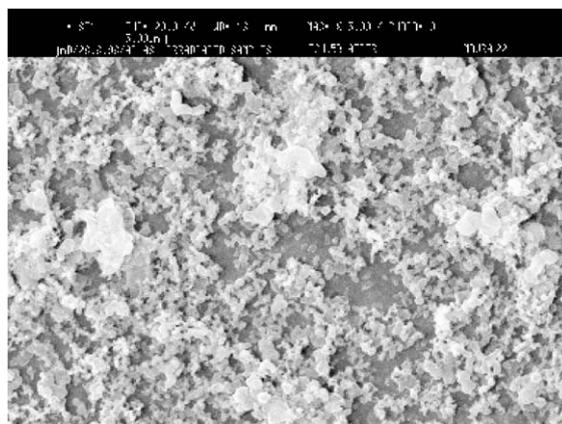
Only slightly visible changes of the cathode were observed. A detailed mass-spectrometer analysis showed a small reduction of the relative oxygen concentration. This indicates that the amount of polyimide in the protection layer after irradiation has decreased, but most of the carbon is still present to protect the aluminium layer, which shows no sign of damage. It is important also to note that no other effects such as deposits on the wire, sparks nor increased dark currents have been observed, when operating the straws after this amount of irradiation.

Fig. 2. Micro-photograph of the cathode surface after irradiation ($25 \times 20\ \mu\text{m}$).

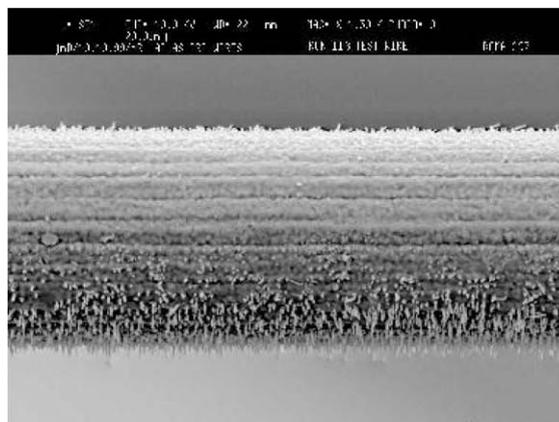
Fig. 4. Anode wire after $0.08 \text{ C}/\text{cm}$ accumulated charge for a straw polluted by Si-lubricant. Such deposits lead to a gas gain drop of about 30%.

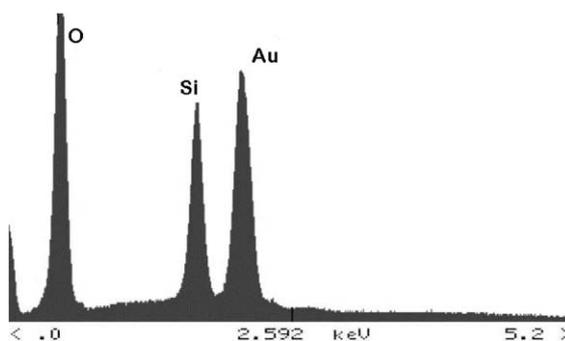
Fig. 5. EDX spectrum for deposit shown in Fig. 4. The peaks on the picture are from left to right: oxygen, silicon and gold.

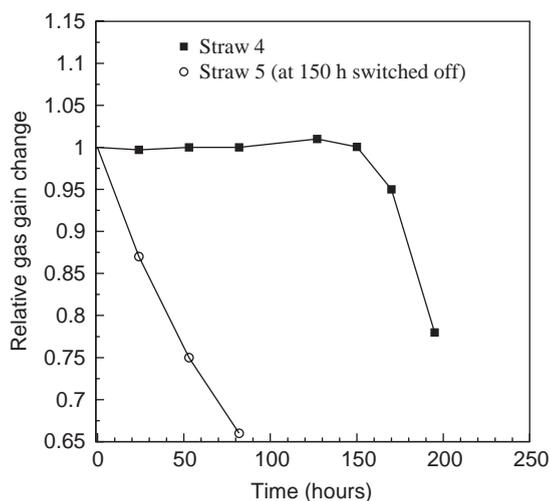
Fig. 8. Relative amplitude variation during irradiation with a narrow beam of 1 mm width where the gas flow is serially from straw 5 to straw 4, and so on. The Si-source in this case is a lubricant used for the assembly of a flow regulator.

the straw. The active gas flow was from straw 5 to 4, and so on. During the first 150 h, all straws were connected to high voltage. Straw 5 showed significant aging immediately, but all the other straws remained stable. After 150 h, straw 5 was disconnected from the high voltage (but left in the gas flow), and significant aging was observed

immediately in straw 4. The Si-source in this case was a lubricant used during flow-regulator assembly. The conclusion is that even a 1 mm wide irradiation area is sufficient to stop downstream Si-transport in this particular case. If the beam is wider, the amplitude degradation is observed first at the gas inlet, but it has a tendency to propagate further. This is shown in Fig. 9, where a 50 cm long straw was irradiated by a 40 cm wide beam, and, after 64 h, a significant amplitude drop was observed up to a distance of 5 cm from the gas inlet. In this test, the main source of Si arose from pollution of the gas system by traces of oil.

corresponds to a test, in which one of the standard flow regulators (“rotameter”) was connected directly to the straw, as received from the manufacturer. Even a short exposure of the detector to such a component may very often leave residuals in the detector itself. For example, the use of this particular flow regulator for 70 h resulted in a significant pollution of the straw: after connection to a clean gas supply line, the straw displayed an amplitude drop of 5% over 100 h of irradiation with a narrow X-ray beam.

Some recommendations, which should help to guarantee the cleanliness of the gas-system can be listed as follows:

- Validate samples from the manufacturer in all cases;
- Specify and control the production process of all components as carefully as possible;

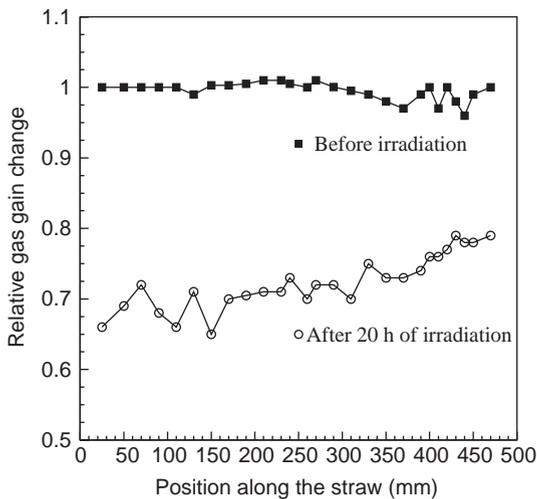
(b) In the case of a much stronger external source of Si (large pollution of the gas system by a Si-containing lubricant), there is not enough ionisation to stop all the Si and it is distributed along the straw. In this case, fast aging happens along the whole straw at the same time, as shown in Fig. 10 for a current density of $0.03 \mu\text{A}/\text{cm}$.

Fig. 10. Aging due to a strong external source of Si. The relative amplitude variation is shown as a function of the position along the straw before irradiation and after 20 h of irradiation with an X-ray beam along the full length of the straw and at a current density of $0.03 \mu\text{A}/\text{cm}$.

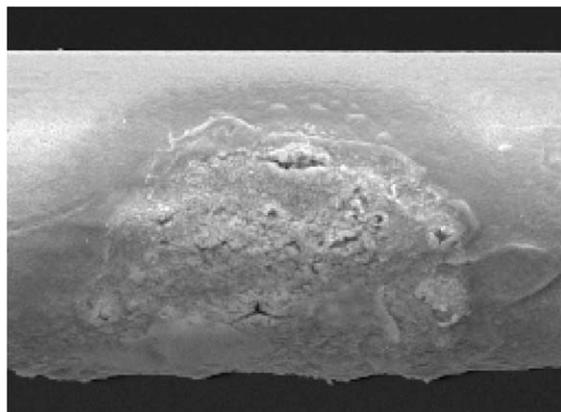
Fig. 11. Damage of the wire gold-plating after 2 C/cm of accumulated charge for a current density of $0.7 \mu\text{A}/\text{cm}$. Local deformation of the gold plating leads to an effective wire diameter increase.

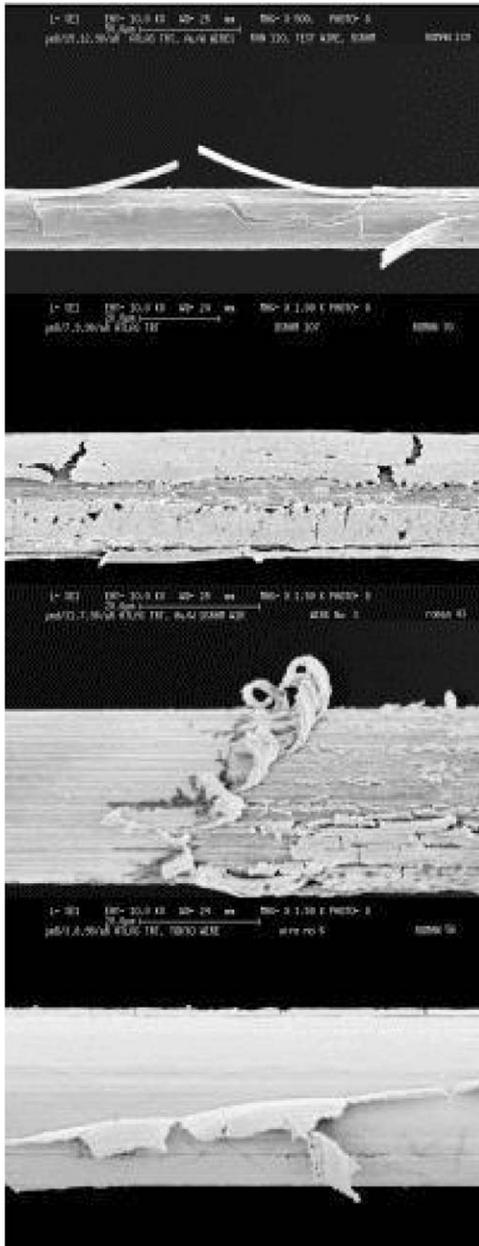
At higher dose rates, the damage is larger at the edges of the irradiation area. In some cases, active chemical processes under the gold-plating are clearly observed (the gold comes off in the form of chips). Wire swelling, or more precisely, swelling of the tungsten, has also been observed, but in contrast to the results reported in Ref. [10], this is not a very reproducible phenomenon: it happened just twice out of about 30 tests. In some tests, damage of the tungsten wire itself was observed, but these are rare occasions. The gold-plating layer very often becomes porous before further damage occurs. Tungsten oxide deposits are observed in certain cases, but not regularly;

Fig. 12. Various manifestations of damage to gold plating on wire surface after 2–6 C/cm of accumulated charge for different current densities (1–4 $\mu\text{A}/\text{cm}$).

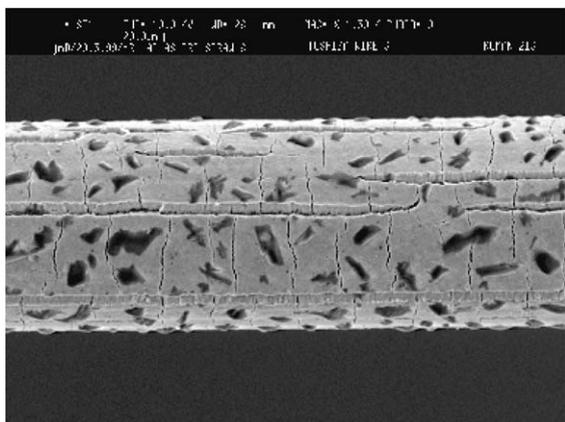
Fig. 13. Damage to gold-plating on wire surface observed after 6.5 C/cm of accumulated charge for the wire manufacturer chosen for the TRT (Toshiba). The gas mixture was the standard one with an additional 1.2% of water.

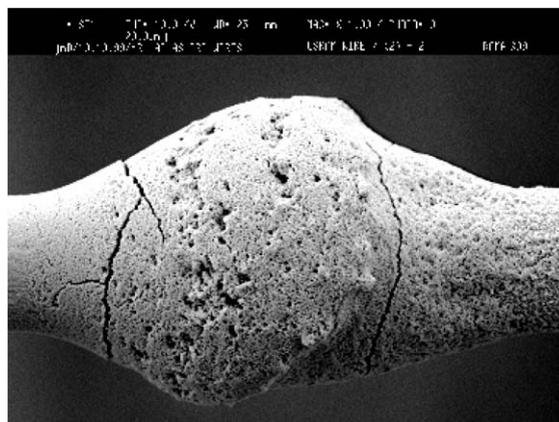
Fig. 15. Surface of wire (OSRAM) observed after 0.5 C/cm of accumulated charge, for the standard gas mixture with 1.2% of water and 1.5% of oxygen added. Amorphous deposits of WO are observed (see Fig. 16).

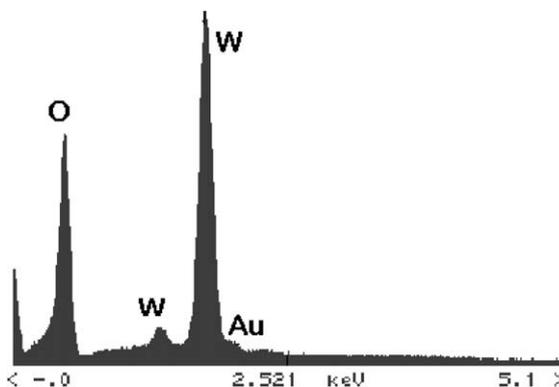
Fig. 16. EDX spectrum of the deposit on the wire shown in Fig. 15. The two largest peaks correspond to oxygen (left) and tungsten (right).

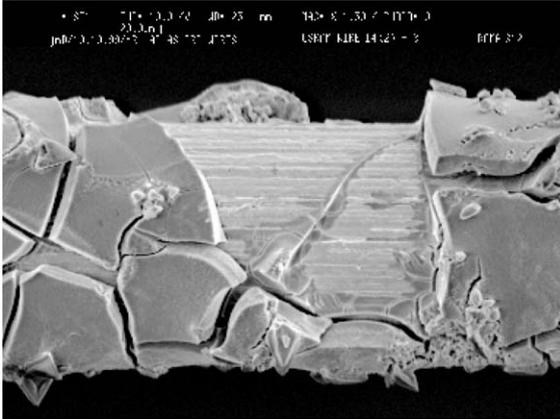
accumulated charge. One can clearly distinguish the undamaged gold surface in the cracks of WO deposits in Fig. 17.

Fig. 17. The same as in Fig. 15 for a different wire sample: crystalline deposits of WO are observed.

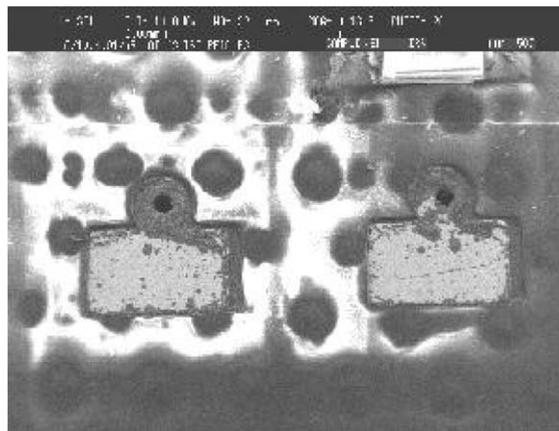
Fig. 21. Printed-circuit board with coverlay partially etched off after 300 h of glow discharge tests.
