Nuclear Instruments and Methods in Physics Research A 515 (2003) 166–179

Aging studies for the ATLAS Transition Radiation Tracker (TRT)

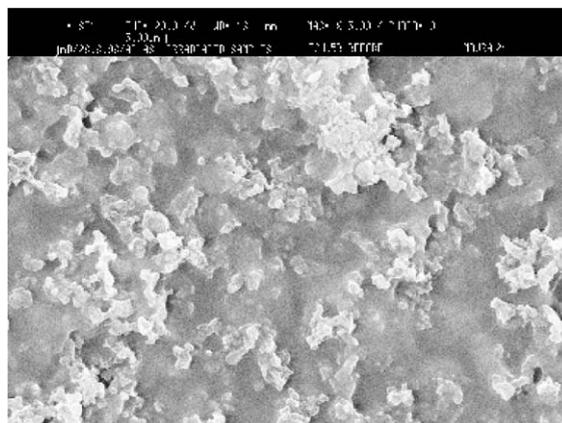
The electro-chemical reactions occurring in the straws operating under irradiation produce active species, which may attack the cathode surface and cause damage. In order to define the final specifications of the coating procedure for the TRT straw production, we carefully studied the cathode robustness up to very large irradiation doses. Micro-photographs of samples of coated film produced according to the final specifications are shown in Figs. 1 and 2, respectively, before and after irradiation ($18\ \text{C}/\text{cm}$ total accumulated charge).

Only slightly visible changes of the cathode were observed. A detailed mass-spectrometer analysis showed a small reduction of the relative oxygen concentration. This indicates that the amount of polyimide in the protection layer after irradiation has decreased, but most of the carbon is still present to protect the aluminium layer, which shows no sign of damage. It is important also to note that no other effects such as deposits on the wire, sparks nor increased dark currents have been observed, when operating the straws after this amount of irradiation.

Fig. 1. Micro-photograph of the cathode surface before irradiation ($25 \times 20\ \mu\text{m}$).

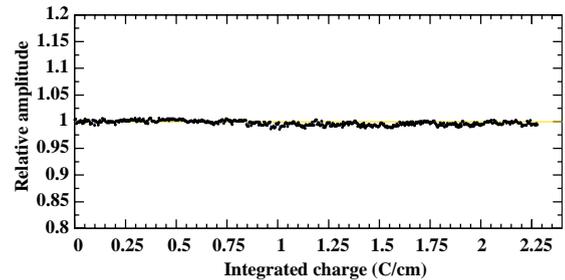
Fig. 3. TRT material tests: relative amplitude variation as a function of accumulated charge for a 1 $\mu\text{A}/\text{cm}$ current density in the straw.

irradiated with an X-ray beam 1 cm wide. These tests were performed with current densities of about 1 and 0.1 $\mu\text{A}/\text{cm}$ (the latter corresponding to the expected maximum current density in the straws at the LHC design luminosity). Typical relative gas gain variations as a function of accumulated charge are shown in Fig. 3.

No noticeable gas gain drop was observed under any of the test conditions. Some materials produced a detectable amount of hydrocarbon outgassing, but no wire deposits were observed after detailed wire analysis under an electron microscope. No indication of Si-deposits was found from G10 nor from FR4 materials, even if some of them smelled rather strongly after machining and irradiation (this outgassing was not detected by the gas chromatograph/mass spectrometer).

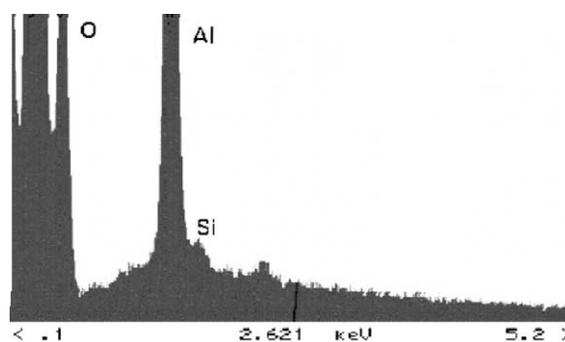
However, the straw material itself (carbon coating) contains very small amounts of Si, which may under specific conditions produce some aging effects. A typical Energy Dispersive X-ray (EDX) spectrum of the straw surface obtained during studies under the electron microscope is shown in Fig. 6. A very small Si-peak near the dominant-Al peak (Al-thickness of $0.1 \mu\text{m}$) can be seen. The total thickness of Si is estimated to be a few molecular mono-layers. The height of the Si-peak varies very much from sample to sample, but never exceeds the value shown in Fig. 6. If such a straw is irradiated with a narrow beam of small intensity, one can observe a gas gain drop over a few hundred hours. An example of this behaviour is shown in Fig. 7: a test straw of 50 cm length was

Fig. 6. EDX spectrum of the straw cathode surface for a straw produced without lubricant. The peak in the middle of the picture corresponds to 1000 \AA of Al. A very small Si peak can barely be distinguished close to the right-hand side of the Al-peak.

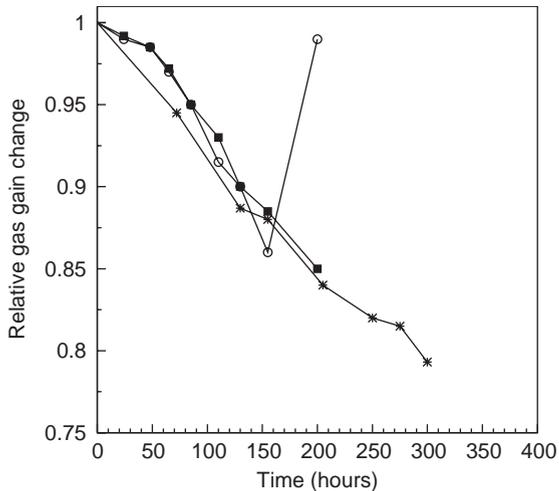
Fig. 7. Relative amplitude variation as a function of irradiation time with a 1 mm wide X-ray beam for three different beam positions along the straw. The last open circle shows the recovery obtained by irradiating that particular point in the straw with a 2 cm wide X-ray beam and a current density of $1 \mu\text{A}/\text{cm}$ over less than 24 h.

irradiated by a 1 mm wide X-ray beam (6 keV) with an intensity of 5 kHz (corresponding to a current density of about $0.05 \mu\text{A}/\text{cm}$). The three curves correspond to different beam positions along the straw (separated by a distance of 150 mm). The observed gas gain drop is the same for any beam position along the straw.

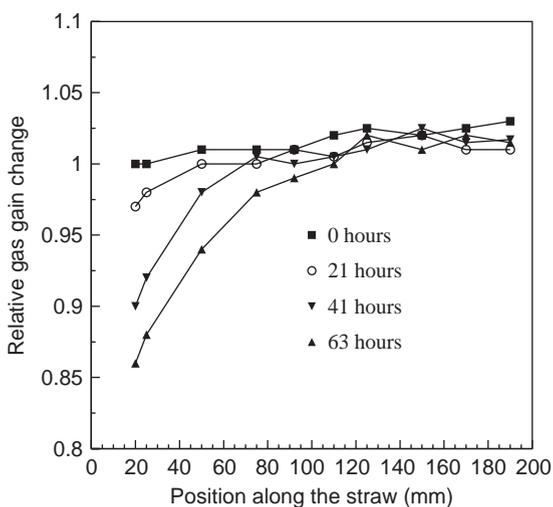
(a) In the case of a rather weak external source of Si, all Si-containing molecules are stopped by the avalanche process and produce deposits only at the beginning of the irradiation area. Two examples of this type of behaviour are shown in Figs. 8 and 9. In both cases, some gas-system components under test were polluted by Si-containing lubricants or oil.

Fig. 9. Relative amplitude variation along the straw for different irradiation periods for a rather weak external source of Si. The straw was irradiated over its full length.

immediately in straw 4. The Si-source in this case was a lubricant used during flow-regulator assembly. The conclusion is that even a 1 mm wide irradiation area is sufficient to stop downstream Si-transport in this particular case. If the beam is wider, the amplitude degradation is observed first at the gas inlet, but it has a tendency to propagate further. This is shown in Fig. 9, where a 50 cm long straw was irradiated by a 40 cm wide beam, and, after 64 h, a significant amplitude drop was observed up to a distance of 5 cm from the gas inlet. In this test, the main source of Si arose from pollution of the gas system by traces of oil.

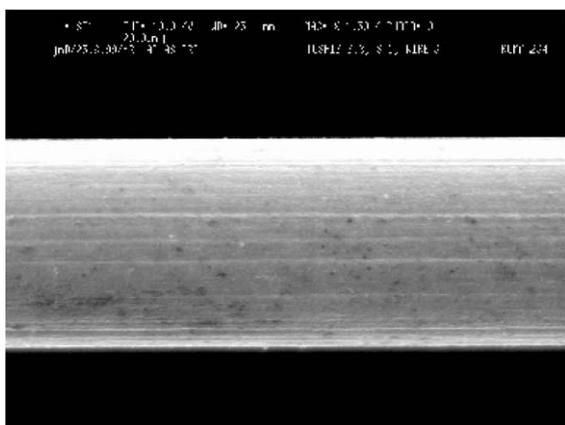
Very interesting results were obtained when combining H_2O and O_2 in the gas mixture. The results were found to depend very strongly on the type of wire. Figs. 15–17 display the results obtained for the standard gas mixture with an additional 1.2% of H_2O and 1.5% of O_2 and for another wire manufacturer (OSRAM). A huge amount of WO deposits were found on top of the gold-plating already after 0.5 C/cm of accumulated charge. These WO deposits exist as an amorphous substance (Fig. 15) or even as a crystalline structure (Fig. 17). In spite of this large observed amount of WO deposits, no significant gold-plating damage was observed for this

Fig. 15. Surface of wire (OSRAM) observed after 0.5 C/cm of accumulated charge, for the standard gas mixture with 1.2% of water and 1.5% of oxygen added. Amorphous deposits of WO are observed (see Fig. 16).

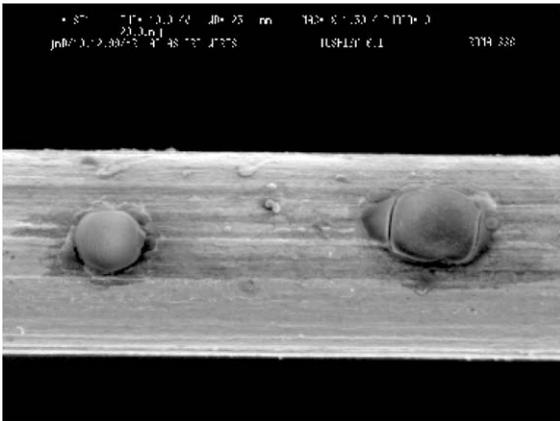
If the water content is kept at a low level, the damage to the gold-plating is minimal. Fig. 18 shows a wire surface (Toshiba), tested with the standard mixture and an additional 0.4% of water after 5 C/cm of accumulated charge (the current density in this test was 1 μ A/cm). For water concentrations below 0.1%, no gold-plating damage is observed up to 20 C/cm of accumulated charge, as illustrated in Fig. 19. Last tests were

Fig. 18. Toshiba wire surface after 5 C/cm. Gas composition: standard mixture + 0.4% of H₂O.

solid WO deposits). These active radicals do not produce any damage in the absence of water. The damage itself very strongly depends on the water concentration and is rather small for water concentrations below 0.4%. Similar problems should be expected with a C₂H₂F₄ gas, even without any H₂O contamination. There is no indication that F creates any solid deposits with any straw material, although it is known that it reacts with Au, Xe, W and O. In these particular tests, all products of chemical reactions with F are volatile (like WF₆) or they react with other components, thereby creating volatile products. Possibly, HF plays the role of a catalyst in the

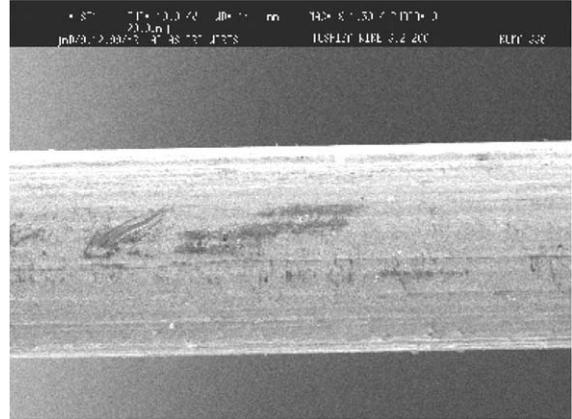
Fig. 19. Toshiba wire surface after 20 C/cm. Gas composition: standard mixture, water concentration less than 0.1%.

chemical processes near the wire. No damage has been observed at water concentrations below 0.1% for all combinations of gases (Xe, CO₂, CF₄, O₂) and for all wire types at current densities above 1 µA/cm.
